Harrison Hotel - Energy Audit Report

Report version: 1.1
Author: Ben Thompson, Peralta Energy

Report prepared for: EMG Corp.

Property address:
1415 Harrison Street, Oakland CA 94612

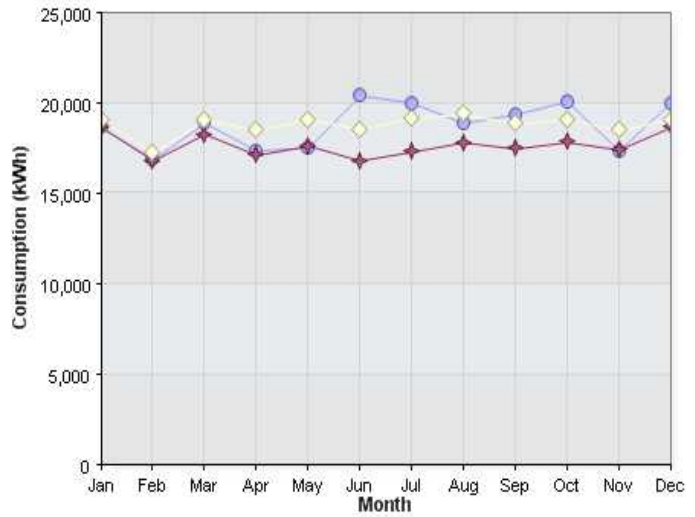
Pre-retrofit electricity:

- Blue line is actual billing data.
- Red line shows modeled usage using 30 year average weather.
- Yellow line shows modeled usage with weather data for the same period as the actual billing data.

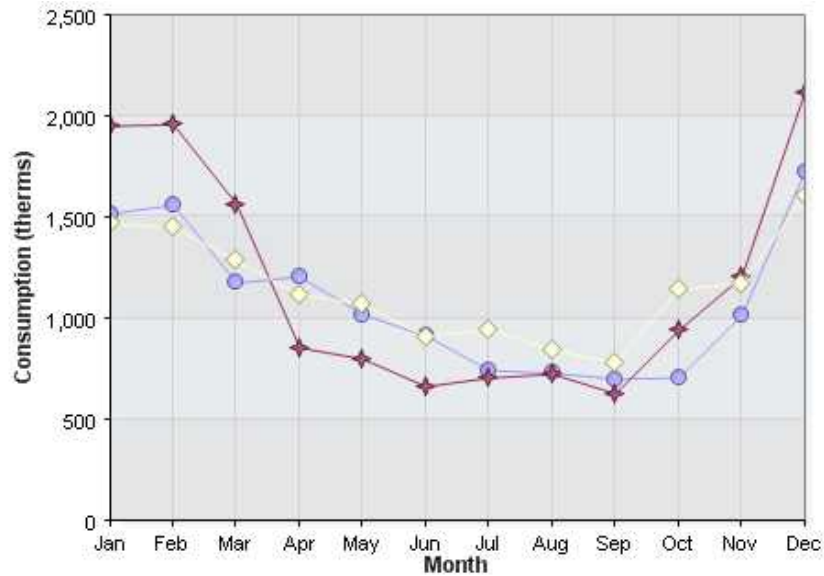
Pre-retrofit gas:

The period was mild compared to average years (mild winter).

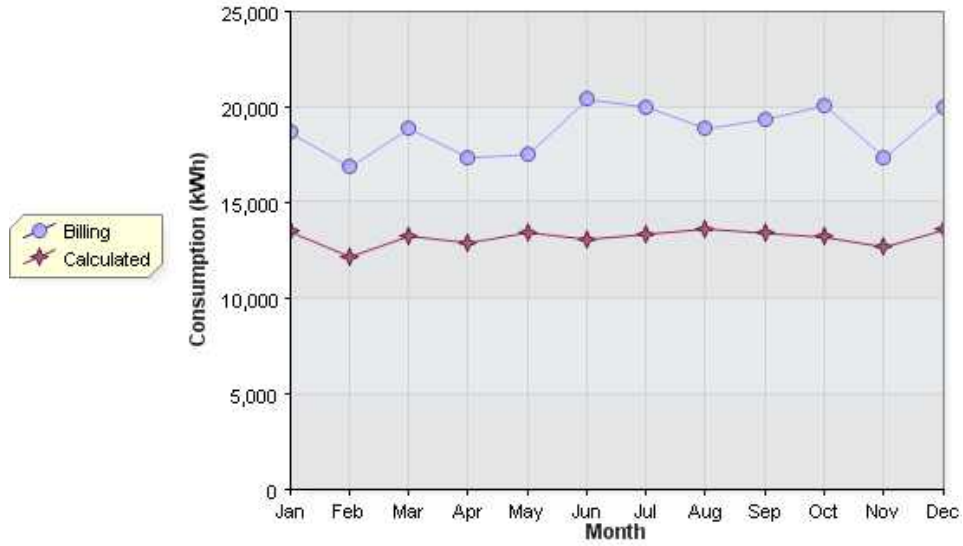
After retrofit predicted electricity (red line) compared to recent billing data (blue):

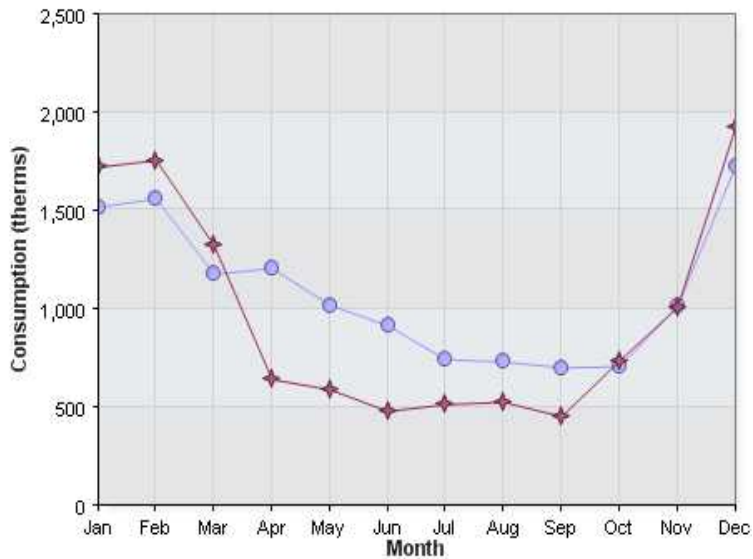
After retrofit predicted gas (red line) compared to recent billing data (blue):

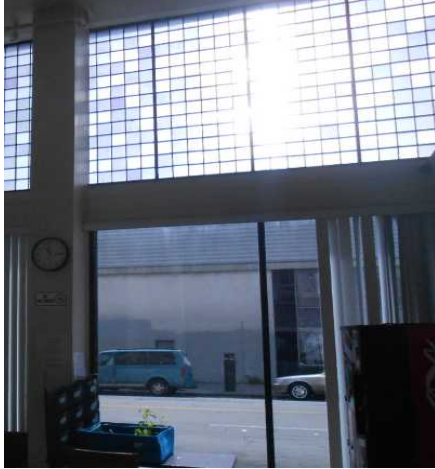
Windows: Windows in all units are dual pane with non-metal frames. Six units also have '8-lite' wood doors to the fire escape. Windows in these doors are single pane. The lobby area has single pane site built windows with metal frames.

Windows in lobby are single pane, metal frame.

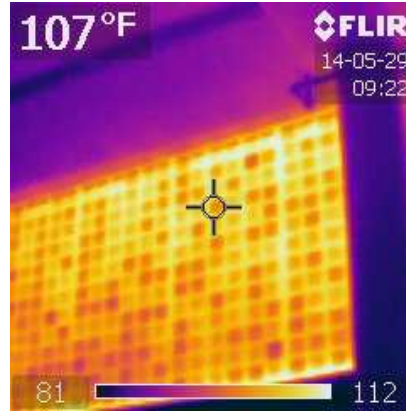
Lobby windows make a big load on the cooling system. (Thermal image.) Install shade devices on exterior.

Install two rows of shading devices over both upper and lower rows of lobby windows to reduce cooling load. Shading devices are assumed to project out 4 feet from building and be level with tops of windows. The reduced load on the air conditioning system more than offsets the increased load on the heating system.

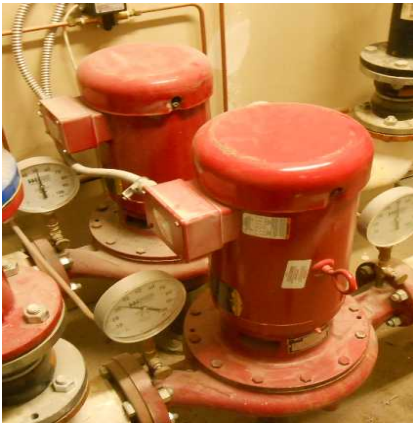
Hot water pump motors are fixed speed. Install variable speed motors for significant savings.

Replace fixed speed pump motors that provide heat to apartment radiators with variable speeds pump motors. This will provide the single biggest source of energy savings in the project.

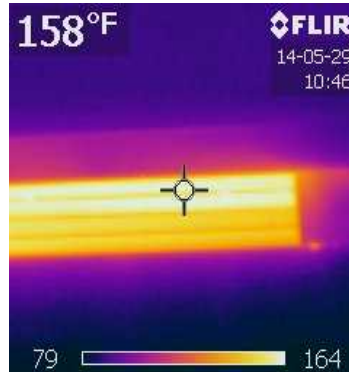
Install outdoor air temperature reset control to shut down boiler when outdoor air temperature rises above set point. During inspection, the boiler was found to be delivering heat to apartments when the outdoor air temperature was 72 degrees and the coolest apartment (second floor shady side of building) was measured at 75 degrees with the window open. For modeling purposes, the savings has been calculated by reducing the heating hour schedule.

Thermal image. Radiator is delivering heat while apartment window is open and outdoor air is 72 degrees. Install outdoor air reset on boiler.

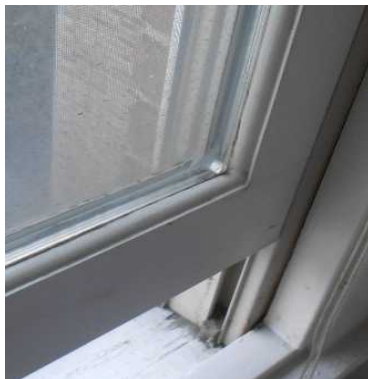
All apartment windows are high efficiency dual pane with non-metal frames.

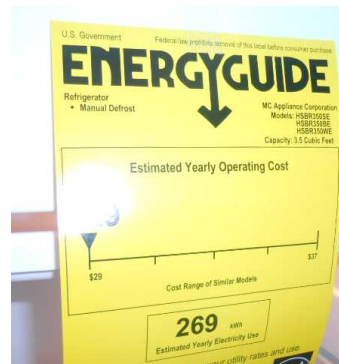
Refrigerators in all units are high efficiency.

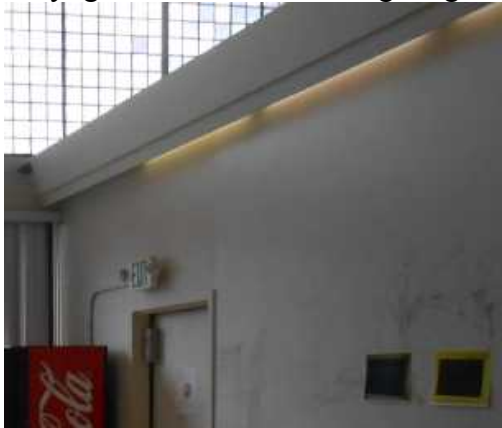
Lobby lights are on while daylight is bright. Install daylight sensors to reduce lighting.

Install daylight sensors to reduce lighting hours in the lobby. Replace T12 lamps with T8 lamps. For modeling the savings is calculated by changing lighting schedule from 24 hours to 'Hotel' hours, and by reducing lighting power density from 0.7 watts/ft² to 0.5 watts/ft² in the lobby.

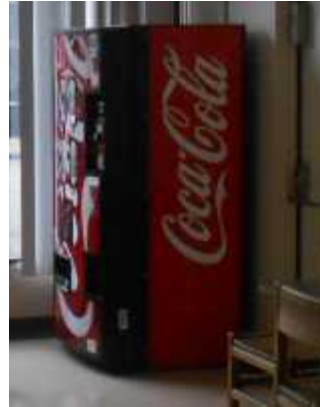
Install an 'energy miser' on the soda vending machine. Payback one year.

Install 'energy miser' on vending machine. This is a simple 'plug & play' type measure. Savings of approx \$100/yr is not included in energy model because the machine is not a building component.

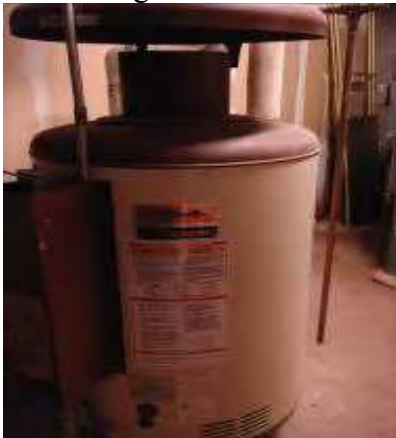
Replacement of domestic hot water boiler with high efficiency condensing unit is recommended for significant savings.

Replace existing domestic hot water boiler with high efficiency condensing boiler. Existing boiler is 21 years old (manufactured 1993). Replacement will provide significant savings. Savings are based on new model: Hamilton Engineering - EVO Duo HWDN00299ASME

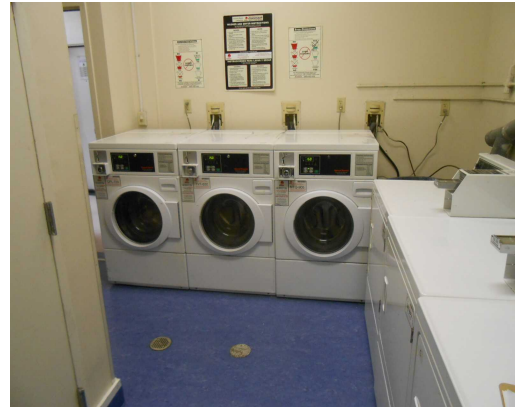
Replacement of washers and dryers is not recommended at this time.

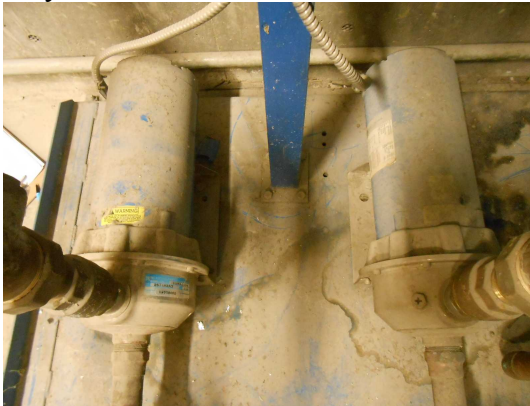
NOTE: Existing parallel booster pumps are not operating due to poor condition of pumps. No water pressure problems are reported, but there is currently no way to boost pressure in the event of a reduction in street water pressure. Savings estimate is based on four hours per day of normal operation for a single pump.

These water pressure booster pumps are not currently in service.

Also replace water supply pressure booster pumps with variable speed pumps for additional marginal savings.

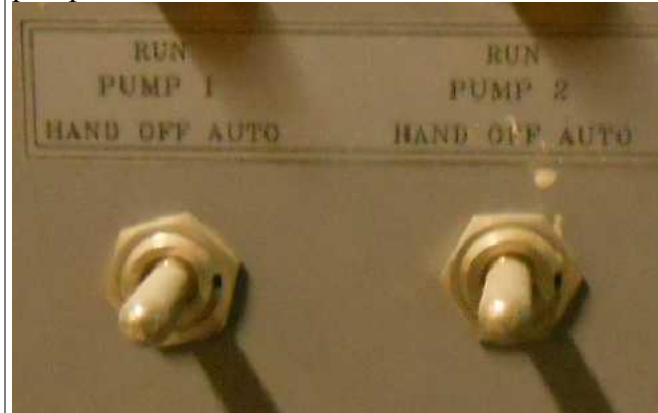
Pumps are switched off due to poor condition of pumps.
